## ASSET CONDITION REPORT

# BOBCAT T450

**BOBCAT T450 COMPACT — INSPECTED  
IN WA, 4 JUN 2026.**

**PREPARED FOR**  
Private buyer, Perth  
Name withheld**INSPECTED**  
4 JUN 2026  
Perth**INSPECTOR**  
Cowan Roberts**REFERENCE**  
RS-ACR-SAMPLE  
Rev. 0 — Initial  
Issue

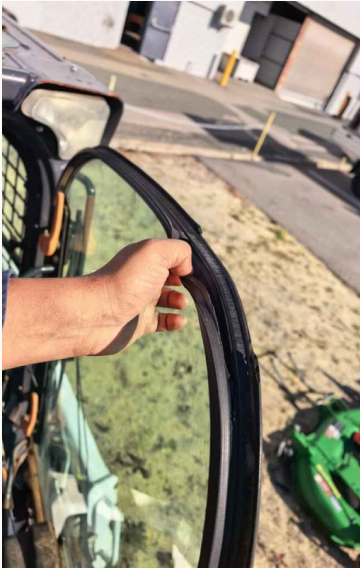
| 01 | <div>COSMETIC</div> 100-01GENERAL WALKAROUND00 | <div>Door Seal Torn</div> Upper Door/window seal is torn and damaged | IMG-01COSMETIC |

Cab door and window seal is torn.

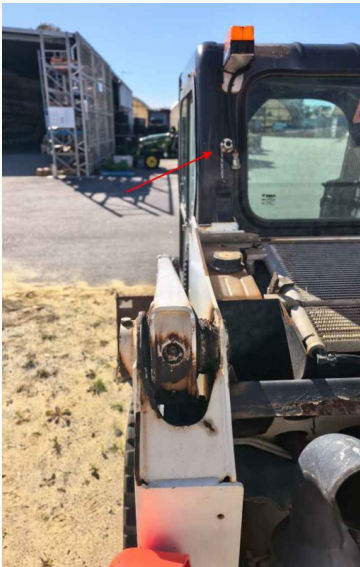
| 03 | <div>PRODUCTIVITY</div> 130-01ELECTRICAL50 | <div>Beacon U/S</div> Flashing Beacon does not work, Power confirmed at plug | IMG-03PRODUCTIVITY |

Five lighting and beacon items. Left headlight, right drive light, and right brake light all need globes. Brake light housing is loose. Interior cabin light works intermittently, likely a poor connection. Flashing beacon is dead with power confirmed at the plug, so the unit or its connection is the problem, not the wiring back to the panel. Globes and the housing are cheap. Beacon and interior light need a quick diagnosis before buying parts.

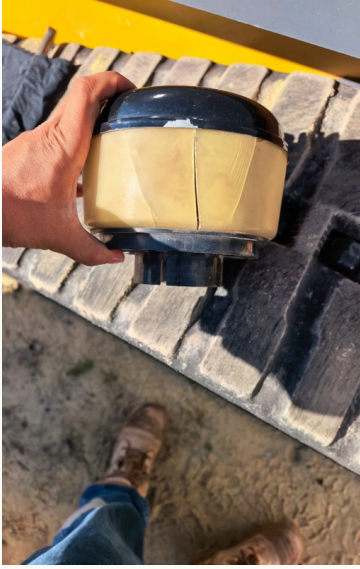
| 08 | <div>PRODUCTIVITY 200-03 ENGINE</div> <div>20</div> <p><b>Pre Cleaner Bowl</b></p> <p>Pre Cleaner bowl is cracked</p> | <div>IMG-08 PRODUCTIVITY</div> |

The pre-cleaner bowl is cracked. Cheap fix, do it before dust gets through. Bobtach coupler pins show 1 to 3 mm of visual movement, early-stage wear, watch and replace as it grows.

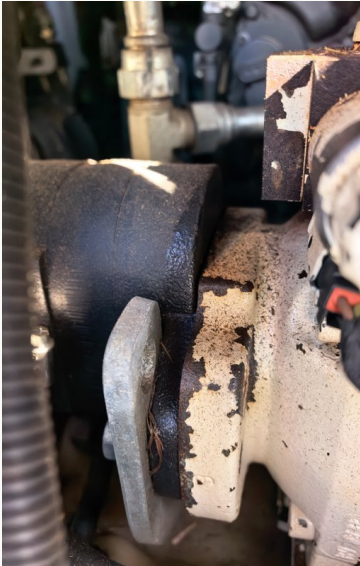
| 09 | <div>PRODUCTIVITY700-01HYDRAULICS</div> <div>10</div> <div><div>Charge Pump Weep</div><div>Charge pump is weeping from where it mounts to the main pump</div></div> | <div></div> <div>IMG-09PRODUCTIVITY</div> |

The hydraulic system has a cluster of small leaks: charge pump weeping where it mounts to the main pump, both drive motor hoses weeping at the connections, the right-hand lift cylinder weeping slightly, and the turbo drain weeping at the flexi hose connection. None catastrophic, all will get worse if left. The turbo drain weep is the one to watch closest because that flexi hose connection lives in heat and vibration, and oil dripping onto a hot exhaust is a fire risk.

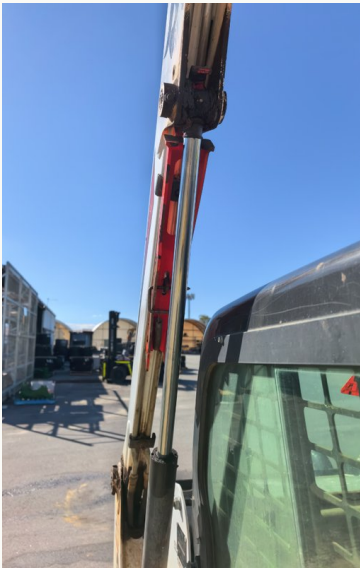
| 11 | <div>PRODUCTIVITY700-02HYDRAULICS</div> <div>50</div> <div><div>RH Lift Cylinder Weep</div><div>Slight weep from RH lift cylinder</div></div> | <div></div> <div>IMG-11PRODUCTIVITY</div> |

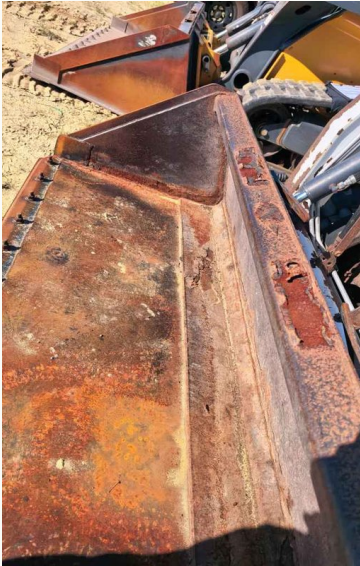
| 15 | <div><div>COSMETIC</div>900-01 ATTACHMENTS</div> <div>20</div> <div><div><b>Bucket Condition</b></div><div>The bucket is in average condition with large amounts of surface rust and corrosion. Floor integrity intact.</div></div> <div><div><div>IMG-15COSMETIC</div><div></div></div></div> |

Fifteen defects across the machine. Twelve productivity, three cosmetic. The bucket and both track frames carry heavy surface rust. The bucket floor is still solid and the track frames are structurally fine, so the rust doesn't stop the machine working, but it tells you the machine hasn't been looked after and a clean and treatment is overdue. The sprockets are about half worn on both sides, not at replacement yet but a known cost in the next service window.
